**Pre-subsidence Survey  
Prior to Full Extraction at Panels**

**1 – 4 North,  
1 – 5 and 7 – 13 West,  
8 South, and  
5 West Mains**

Emery Mine  
Consolidation Coal Company  
Emery County, Utah

June 2008

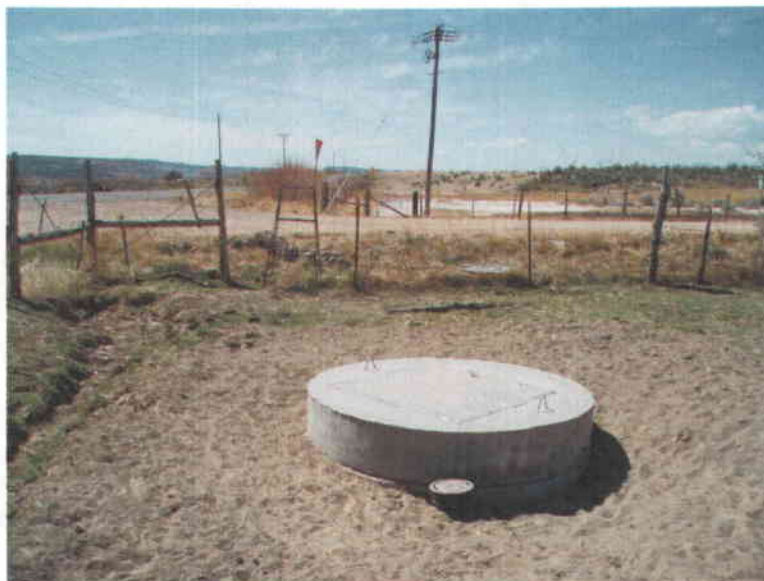
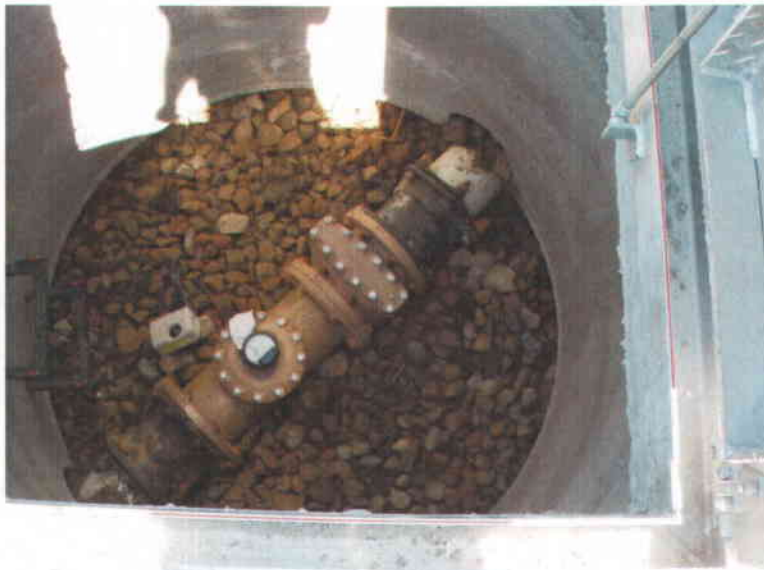
Feature 125. Water Line Manhole with Emergency Shutoff Valve. This feature was constructed after the Valley Engineering (1980) report was written. The manhole is constructed from concrete with an unlocked diamond plate steel trap door. Inside the manhole is an

emergency shutoff valve that has been installed on the water line. The valve is intended to stop the flow of water in the line in the event that subsidence causes the pipe to rupture. The water line lies approximately three feet below the ground surface. A covered water meter is located adjacent to the manhole.

Feature 125. Water Line Manhole with Emergency Shutoff Valve. Looking south.

Feature 125. Water Line Manhole with Emergency Shutoff Valve. View into manhole looking at emergency shutoff valve.
